Stonesfield Orchard

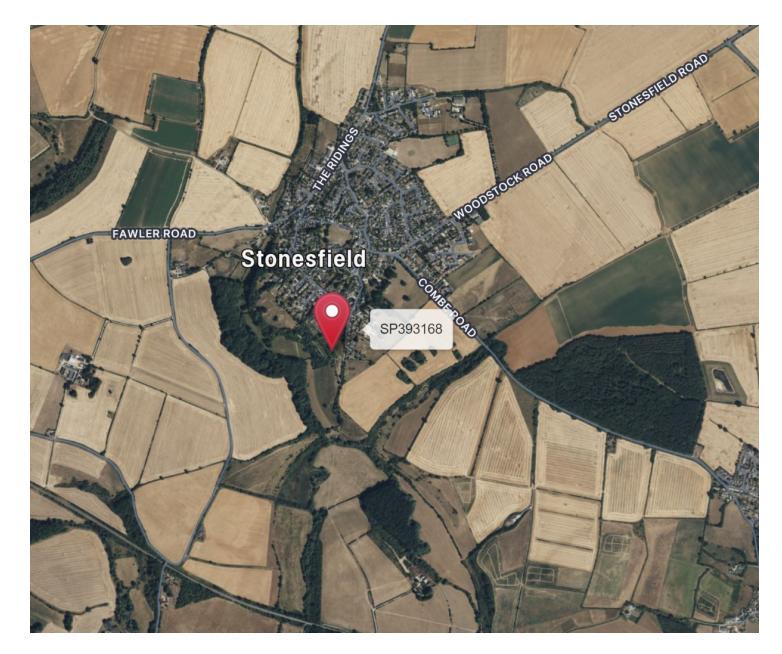
Figure A Orchard Site

The woodland (marked in orange) is in a poor state and although there are significant veteran specimens, these are at risk of collapse due to soil compaction, ivy and old man's beard (Clematis vitalba). The uncontrolled growth of ivy will also impact the dry-stone wall and hamper natural regeneration. Woodland canopy looked stressed (ivy, compaction) consisting mainly of mature/ semi-mature beech, sub-canopy of hazel, hawthorn, field maple and occasional elm, ground flora sparse with dog's-mercury, a mix of ferns and bryophytes. There was a general lack of deadwood. The regeneration was relatively poor, mainly of ash, also some sycamore regenerating, and of course blackthorn.

Blackthorn is becoming a dominant species and non-chemical methods will have to be used to control these three species (Clematis vitalba, blackthorn, ivy) in order that the land not only has an opportunity to naturally regenerate but the identified species (present) are not lost.
